Transport  
Canada

TP 185E  
Issue 2/2008

# AVIATION SAFETY LETTER

## In this Issue...

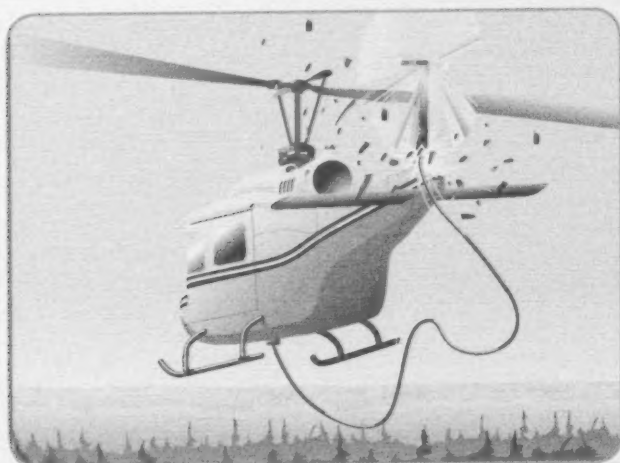
*Artist's impression of catastrophic contact between a light sling load and the tail rotor assembly*

In another longline accident (TSB report A00A0076), a Bell 212 was slinging empty drums from a lighthouse. It was the last load of the day, and the weather conditions were favourable—clear, with a strong wind. For some reason, shortly after takeoff, the helicopter descended until water contact was made with the load, and all was lost. The hook assembly was violently displaced 30° to the rear at water contact. The rotor system suffered mast bumping and shearing during the accident sequence. The tail boom and the tail rotor assemblies separated from the aircraft in flight.

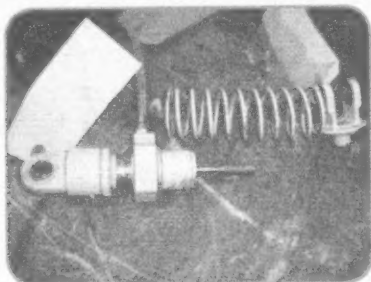
Up-lock actuator, part number 215750098

of their aircraft will experience an unexpected failure of the up-lock actuator shaft. If the failure occurs, in this case, during a high force-loaded part of the flight, such as takeoff, landing or while scooping water, the result may be catastrophic. If everyone shares information using the available process, which is the SDR database, then

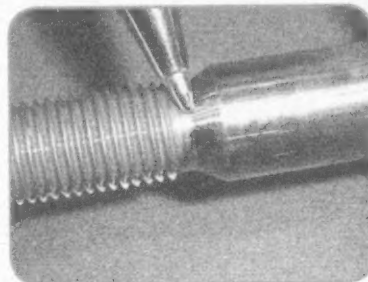
Shaft, part number 33130131, with a defect shown

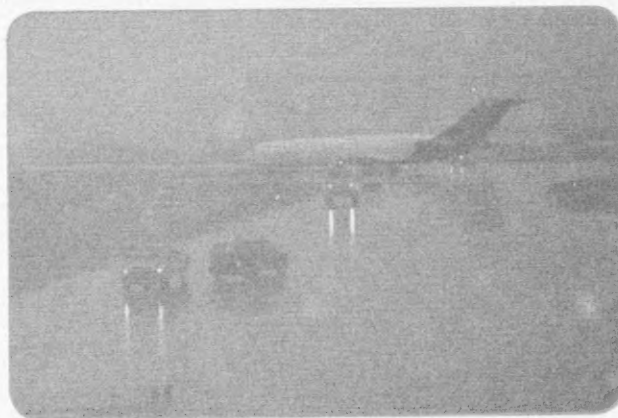
*Aircraft moments after runway excursion*

On August 31, 2004, a Boeing 727-200 cargo aircraft was on a scheduled cargo flight from Toronto, Ont., to Halifax, N.S., with stops at Montréal, Que., and Moncton, N.B. The aircraft landed on Runway 29 at Moncton at about 12:22 Atlantic Daylight Time (ADT). After touchdown, the aircraft hydroplaned and departed the runway at the Taxiway Charlie intersection. It crossed the taxiway and came to rest on an abandoned runway threshold, a short distance from the taxiway. Damage was limited to tread damage to the four main landing gear tires, and destruction of a taxiway light. There were no injuries.

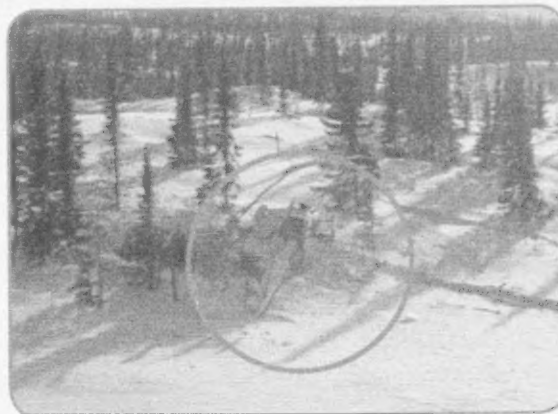
*View of wreckage and accident site*

On January 24, 2005, at approximately 15:00 Eastern Standard Time (EST), the pilot of an Aérospatiale AS 350 BA helicopter, with four hunters and one guide on board, was conducting an approach to an unserviced landing area on the edge of a lake, located in the James Bay area, 60 NM from La Grande-4, Que. At the end of the approach, the helicopter began to hover, and then started to descend into whiteout and loose snow conditions. The downdraught of the main rotor lifted the snow, causing a total loss of visual reference. After the left ski touched the snow-covered surface, the helicopter rolled onto its left side into snow that was several feet deep. During the rollover, the rotor blades struck the ground and the gearbox partly separated from the fasteners. Some blades penetrated the cockpit, fatally injuring the guide and the pilot, who was wearing a helmet. The four passengers sitting in the rear seats were not wearing seat belts, and received minor injuries. Two of the passengers were ejected from the aircraft, and ended up approximately 10 ft from the wreckage; the two others remained in the cabin. The survivors were evacuated by two other helicopters at approximately 16:30 EST.

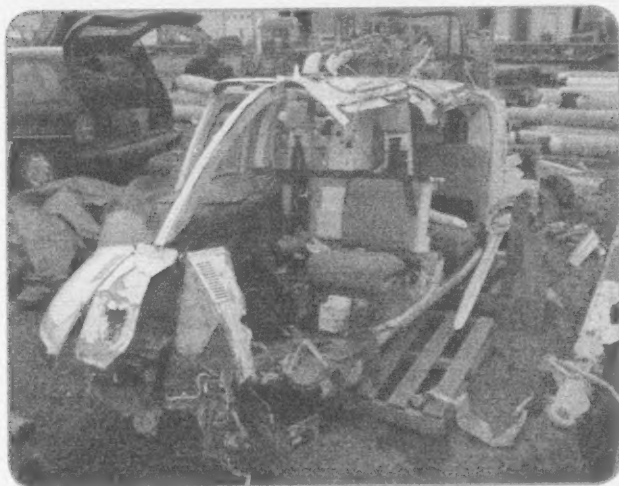
Forward left view of main rotor strike damage to cockpit

7. The main rotor penetrated the left-side cockpit and cabin, contributing to the severity of the injuries to the passengers.
8. It is probable that the passenger in the rear left seat was not wearing the available shoulder harness; this likely increased the severity of his injuries.
